GEOTECHNICAL INVESTIGATION

PROPOSED MERU NTUTU MIXED DEVELOPMENT PHASE 1 ON MERU MUNICIPALITY PARCEL NO. BLOCK 1/357, MERU COUNTY.

Prepared for: National Housing Corporation,
P.O Box 30257-00100,
Nairobi.

© Terraconsult Limited
18 March 2019

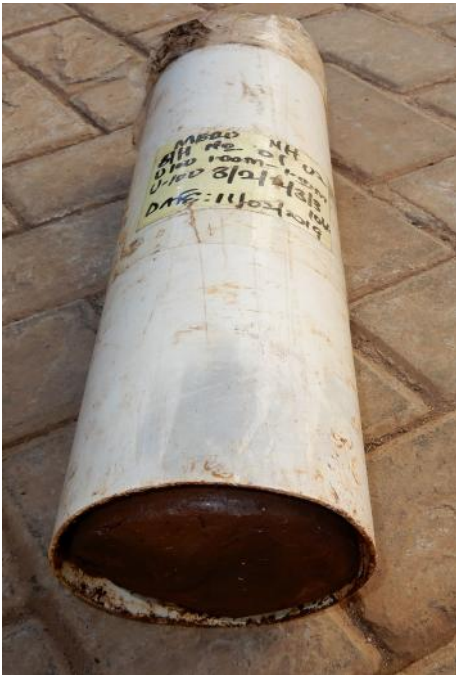
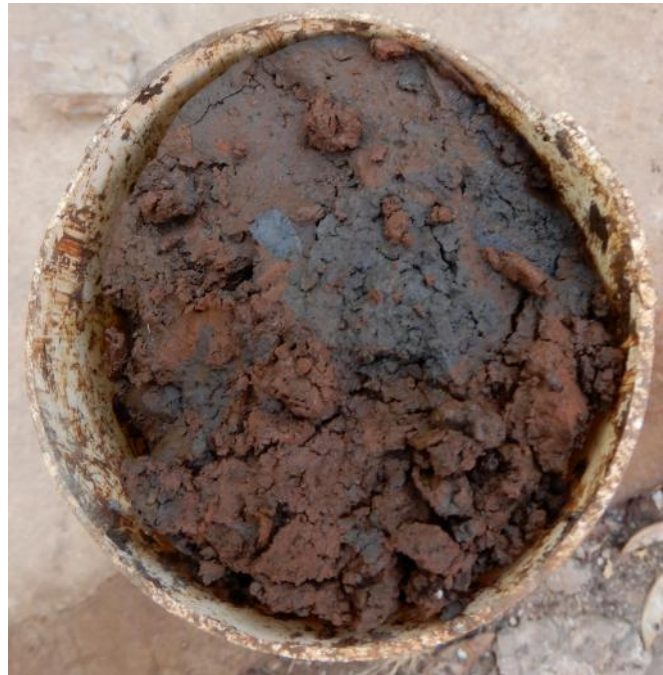
Borehole 101: 1.00-1.50m

Typical U100 (undisturbed) Samples

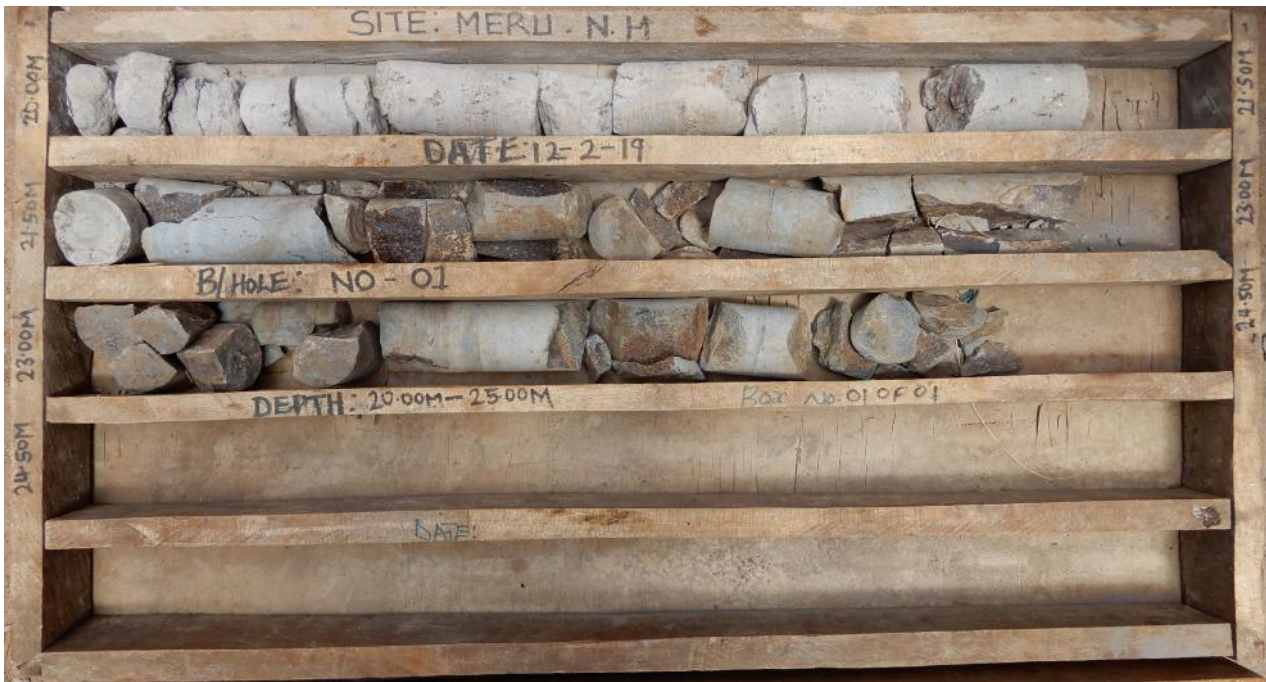
Borehole 101: 20.00-25.00m

DRY SAMPLES

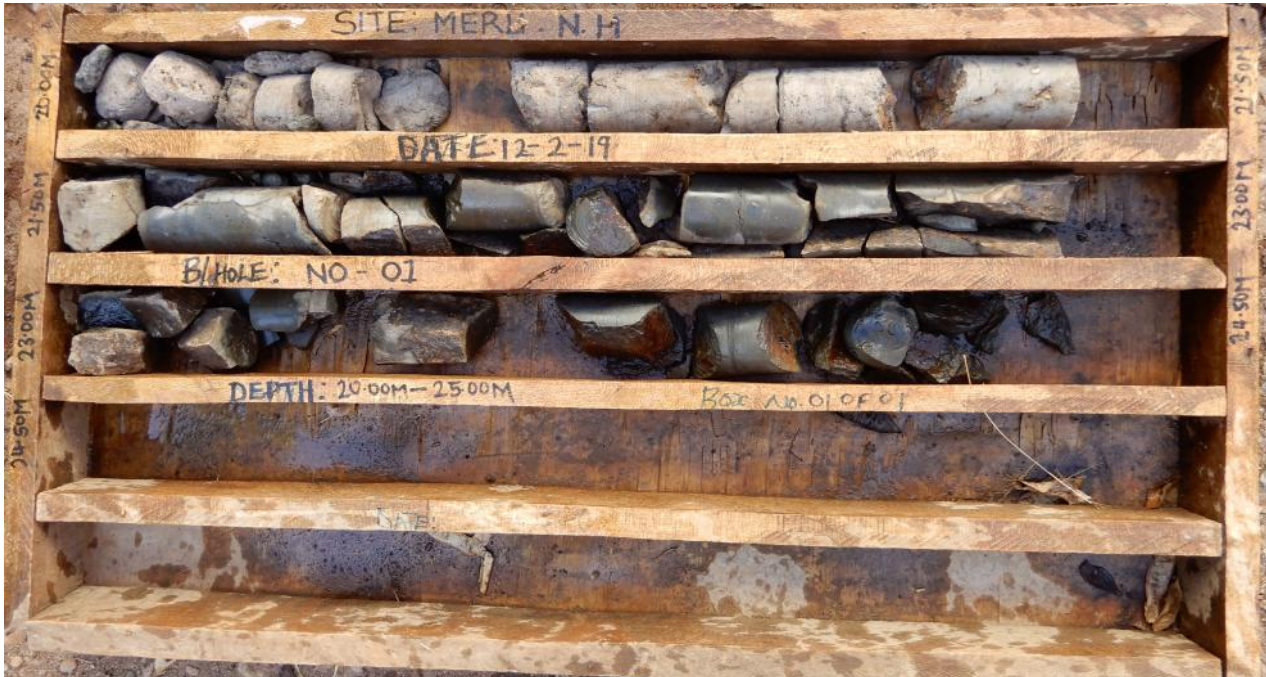
Borehole 101: 20.00-25.00m

WET SAMPLES
