**GEOTECHNICAL INVESTIGATION**  
**PROPOSED BONDENI ESTATE ON LR NO. 451/881- F/R NO. 75/10**  
**NAKURU.**

**Prepared for:** National Housing Corporation,  
P.O Box 30257-00100,  
Nairobi.

Terraconsult was retained by National Housing Corporation to carry out a detailed geotechnical investigation and provide design advice for Proposed Bondeni Estate on Lr No. 451/881- F/R No. 75/10 Nakuru.

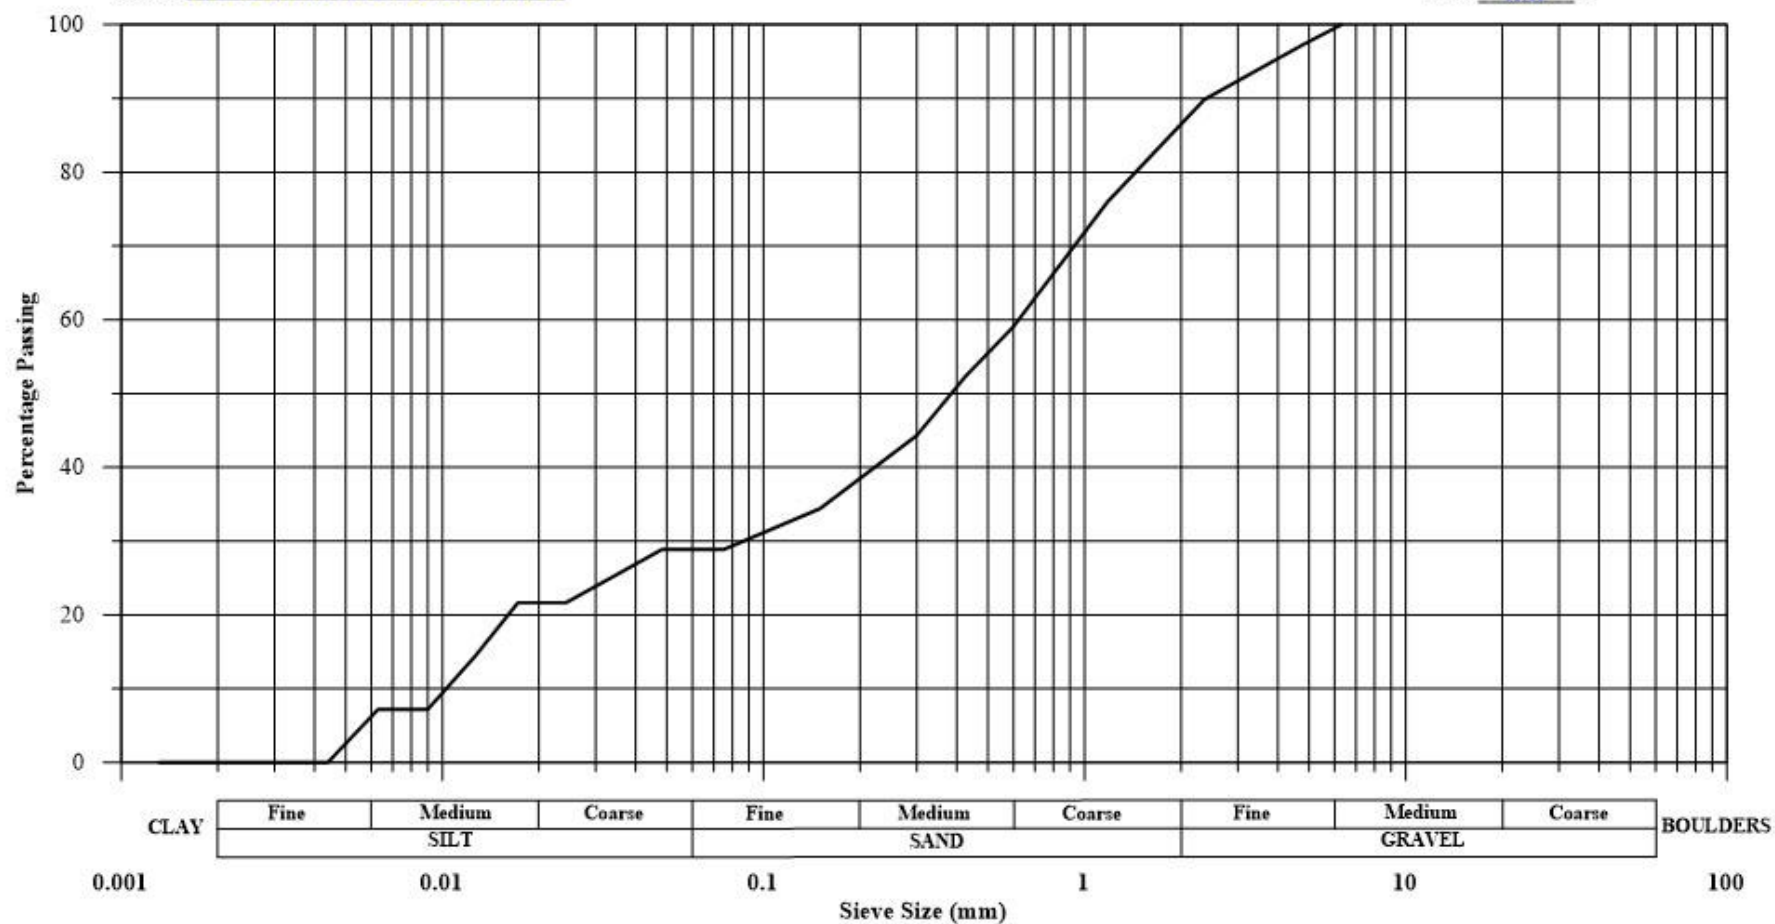
**PARTICLE SIZE ANALYSIS**File No. : 3-19-16Project : PROPOSED BONDENI ESTATE - NAKURUClient : NATIONAL HOUSING CORPORATIONBorehole No. : BH 101Depth (m): 3.0 to 4.5Fines: 53.60 %

Test	Samples	Results
Sieve and hydrometer analysis and Atterberg limits	Bh 101(3.0-4.5)m	Completely decomposed tuff, non-plastic
	Bh 102 (2.0-4.0)m	Volcanic ash, non-plastic
	Bh 103(0.0-1.5)m	Volcanic ash, non-plastic

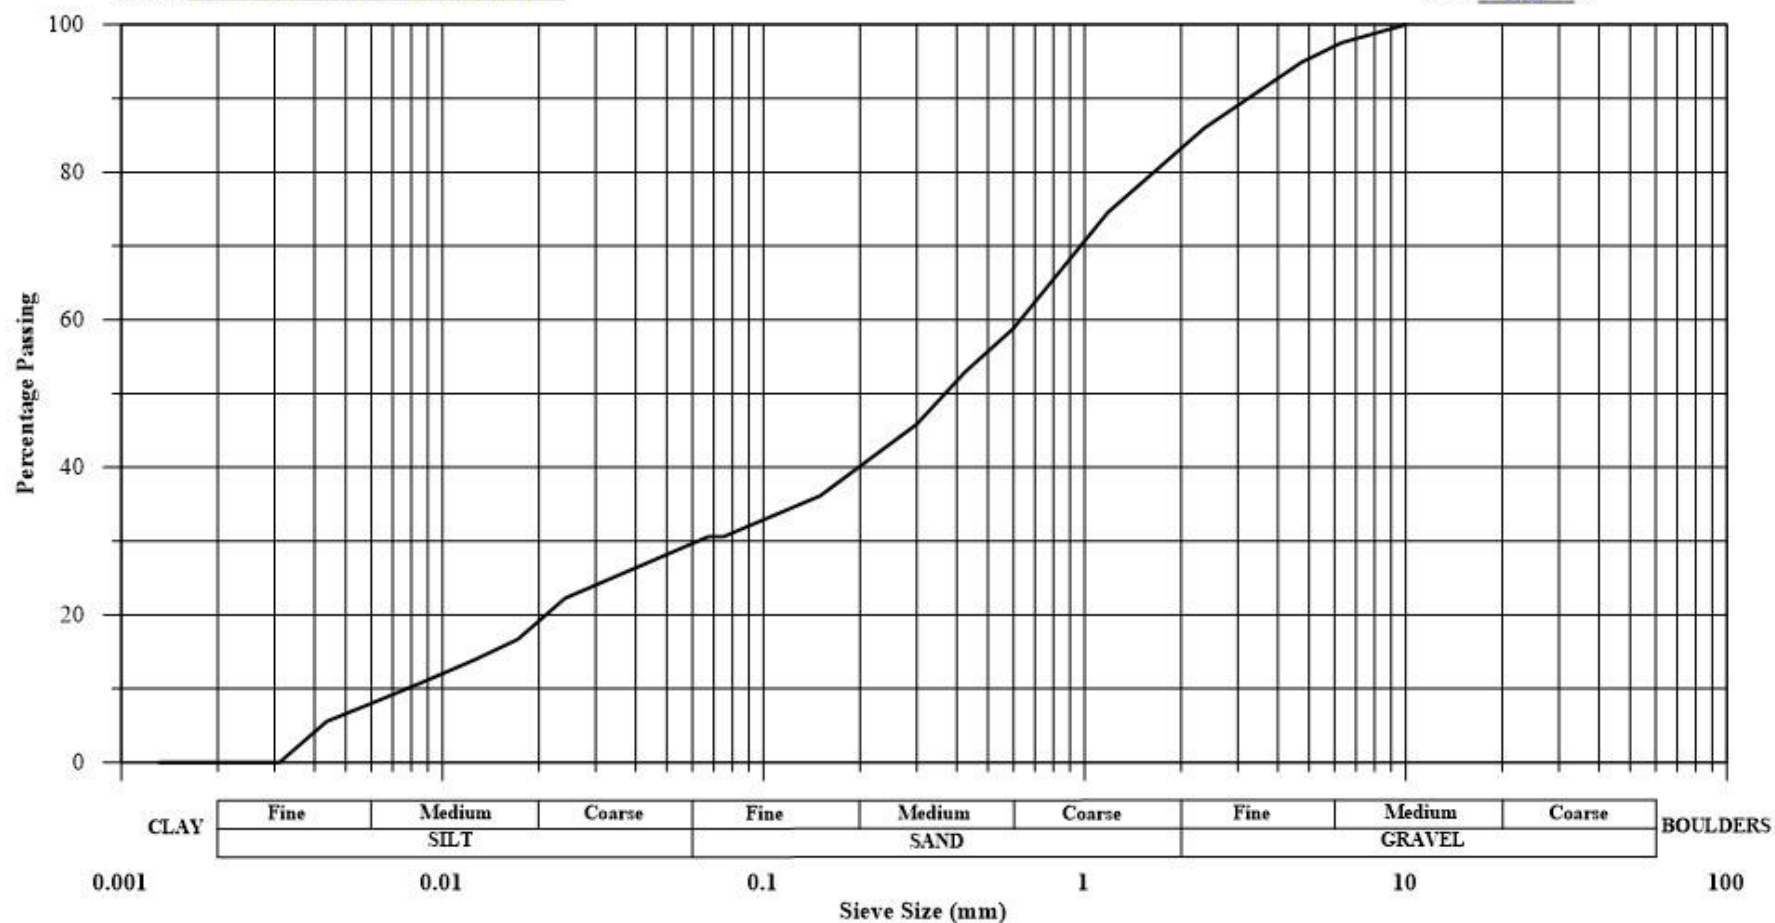
**PARTICLE SIZE ANALYSIS**File No. : 3-19-16Project : PROPOSED BONDENI ESTATE - NAKURUClient : NATIONAL HOUSING CORPORATIONBorehole No. : BH 102Depth (m): 2.0 to 4.0Fines: 30.60 %

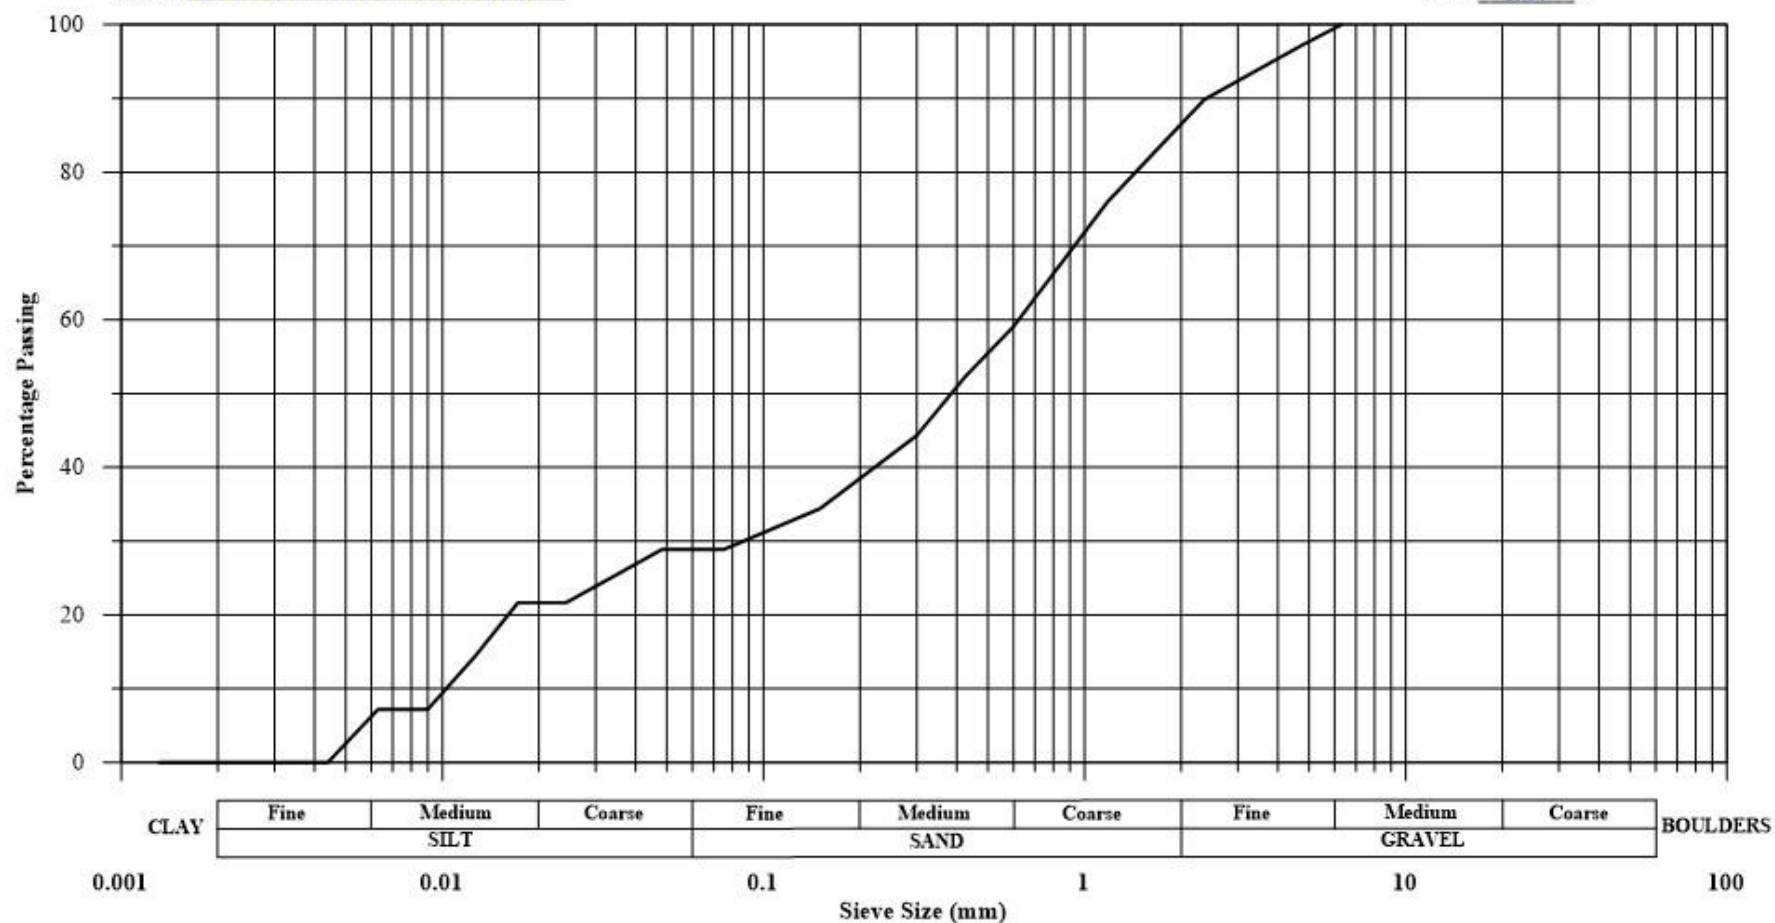
**PARTICLE SIZE ANALYSIS**File No. : 3-19-16Project : PROPOSED BONDENI ESTATE - NAKURUClient : NATIONAL HOUSING CORPORATIONBorehole No. : BH 103Depth (m): 0.0 to 1.5Fines: 28.84 %

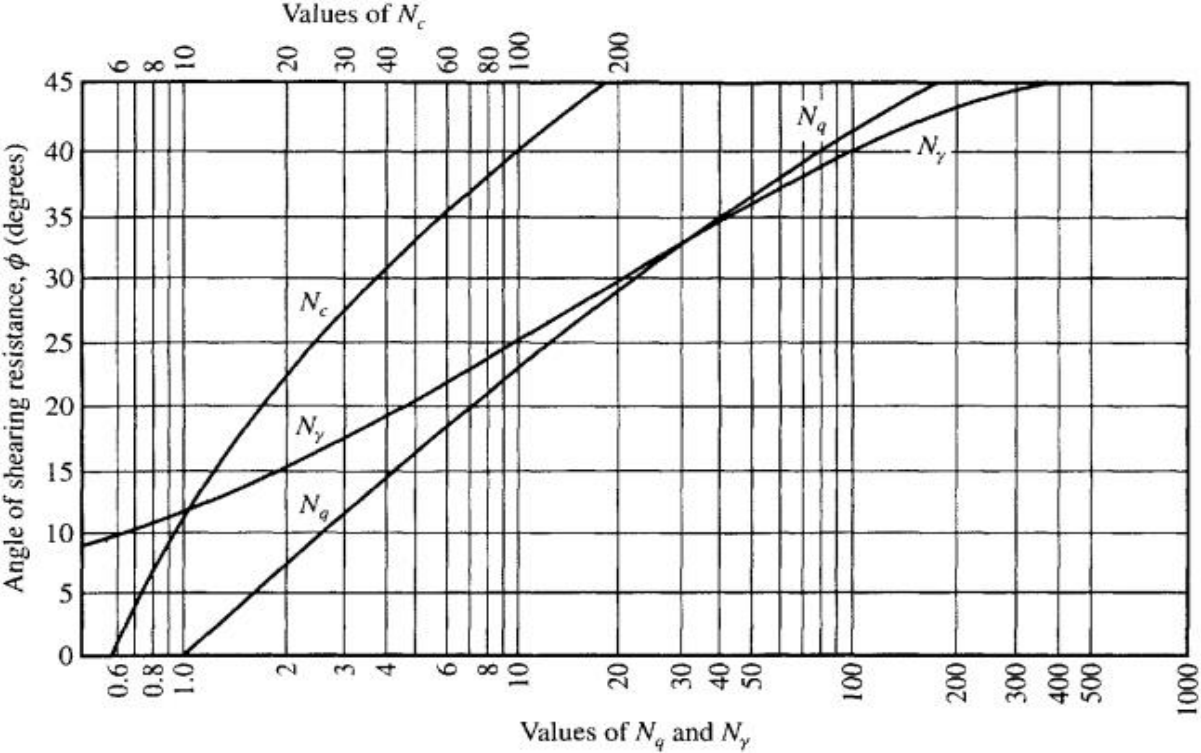
Figure D-1 Terzaghi' s bearing capacity factors

$N_c, N_q, N_\gamma$  = Terzaghi's bearing capacity factors for general shear failure (Appendix D)
